RADC-TR-81-180

RADC-TR-81-180
Final Technical Report
July 1981

FAILURE MECHANISM STUDY OF GaAs TECHNOLOGY

Hughes Aircraft Company

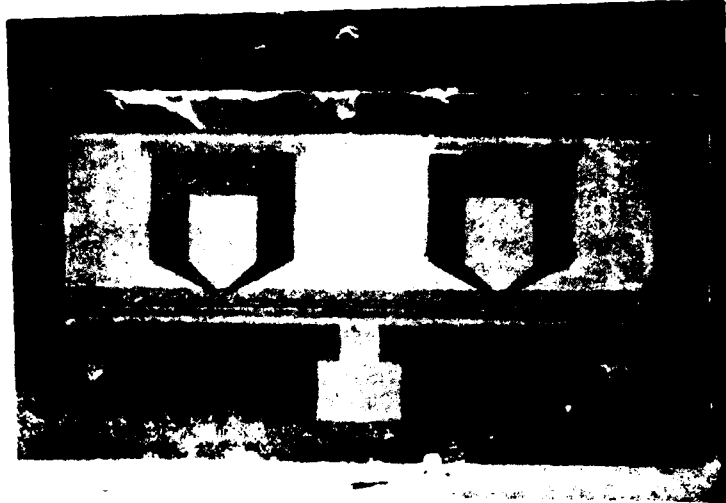
Figure 2-2 FET D-60/8. (a) SEM photograph, overall view, 168 X. (b) Gate connector, showing glass missing in some areas. S-D spacing is 4.7 μm . 4500X mag.

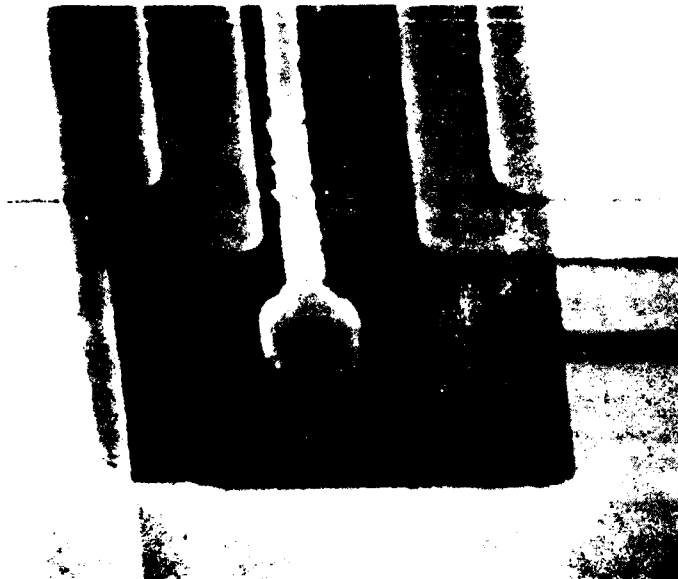
Figure 2-5 FET D-250/6. (a) Overall view. (b) Gate end, showing ragged gate edge and good step coverage.

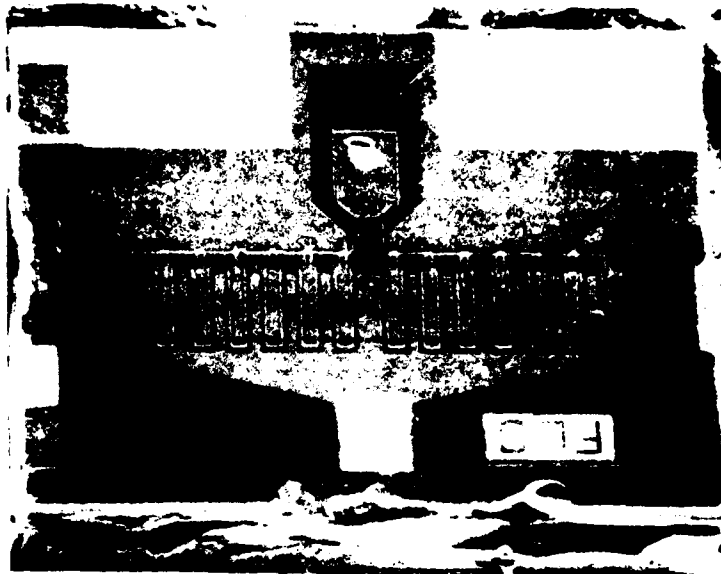
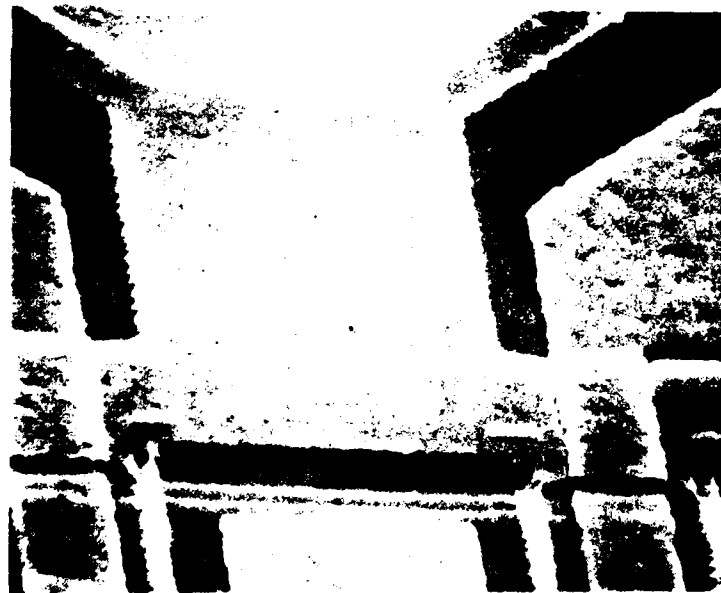
This is a medium power FET, where the gate metallization is connected by an overlay over the source metallization. SEM photographs of the gate prior to the removal of the glass show a ragged gate profile with the top narrower than the bottom. This indicates that the gate was etched rather than lifted. There is some evidence of recessing of the gate electrode. The EDAX scans show only GaAs, aluminum and gold. One EDAX scan does show germanium in the source-drain metallization area, indicating that the ohmic contact is probably gold-germanium. The separation between the gate and source metallization in the overlay area appears to be small. The step coverage is not particularly good, as well, indicating some sites for separation of the gate metallization where it crossed over the source. The mesa on this device shows two etching steps, as have been previously reported for the F-type process. There is little or no evidence of profiling of the channel in this power FET, in contrast to some reports made earlier by vendors F and N. On this device we looked at the SEM photographs to determine which metallization crossed over. On the F-1000/12 device the SEM photographs with the glass attached showed very clearly a difference in contrast between the gate and the source over-crossing metallization. In

Figure 2-8 FET F-600/8 (a) Overall, 170X (b) Gate connector, glass intact. Note ragged gate, poor separation of gate overlay from source by thin glass. Gate is aluminum.

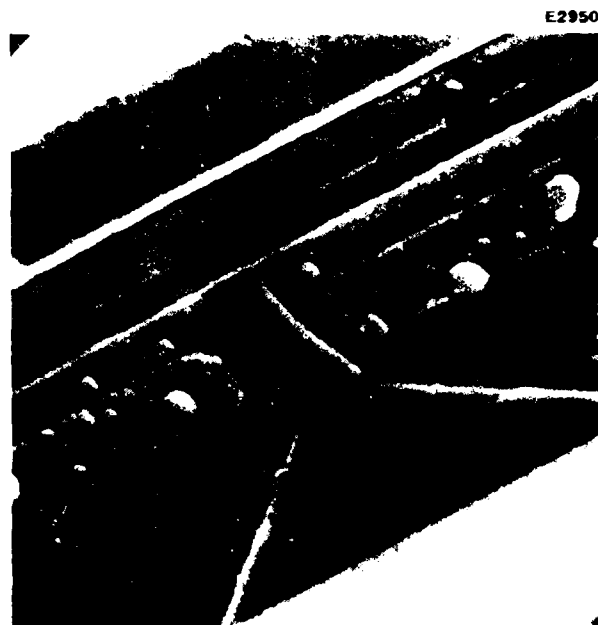
No gold-aluminum intermetallic compound formation was observed. The aluminum/gold pad metallizations showed no obvious degradation. However, widespread degradation was observed in the gold metallization around the periphery of the source and drain ohmic contacts. Voids and nodules formed, as shown in Figure 3-20. Dark spots observed on D-type FETs are discussed in Sections 3.6.2 and 5.3.

Figure 3-20 Type H-11, No. 183 FET. (a) SEM photograph at 2500X of the gate pad to gate stripe transition showing metallization voids and nodules; (b) 6000X photograph of the upper left corner of the drain contact pad in Figure 3-19(a).

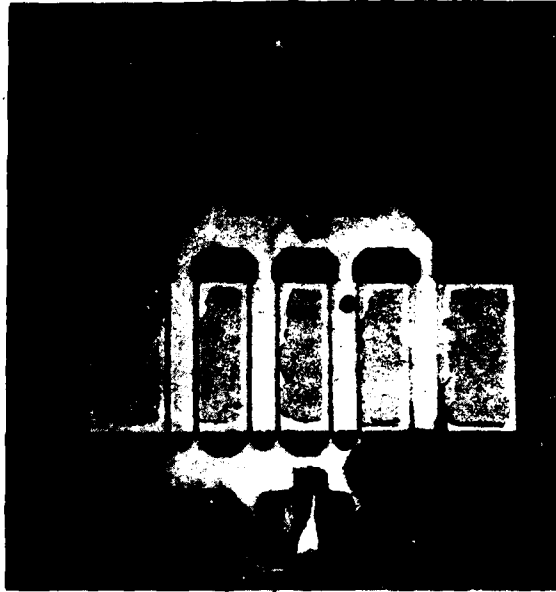
Finally, Figure 4-5 shows a Type M FET that has been removed from its carrier for evaluation. In this case the Au pads remained on the carrier. The failed area is the darkened gate electrode.

Figure 4-5 Type M-400/6, #3,
from Test B.

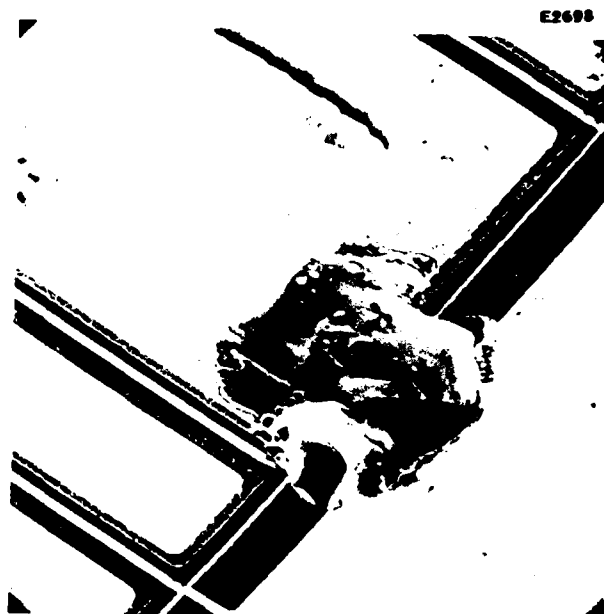
Figure 4-6 shows examples of the catastrophic damage involved for Types D and T FETs. In these two cases the gate and source are primarily involved.

Figure 4-6 (a) Type T-500/8, #11, at 1000X. (b) Type D-250/6, #14, at 2000X.

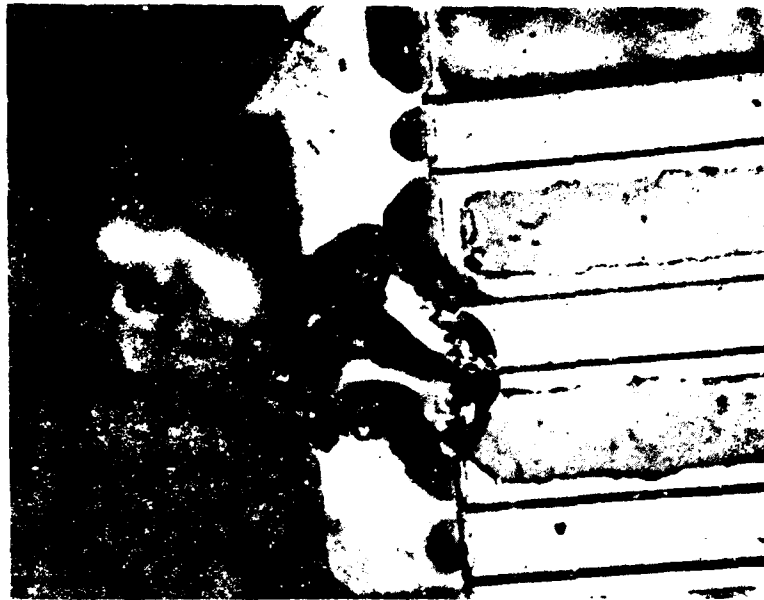
The Type M FET failure, Figure 4-9, was of the "flashover" type at the gate pad. Though we could not see the site well, there was some evidence that the gate finger had erupted, also. This device also exhibited the "flashover" effect from the gate pad to the source and drain.

Figure 4-9 Type M-400/6, #11, Test D. (a) Optical photograph (color original) at 500X. At the top of the photograph note one source pad which remained on-chip after prying of the chip from the heat sink. (b) SEM photograph.

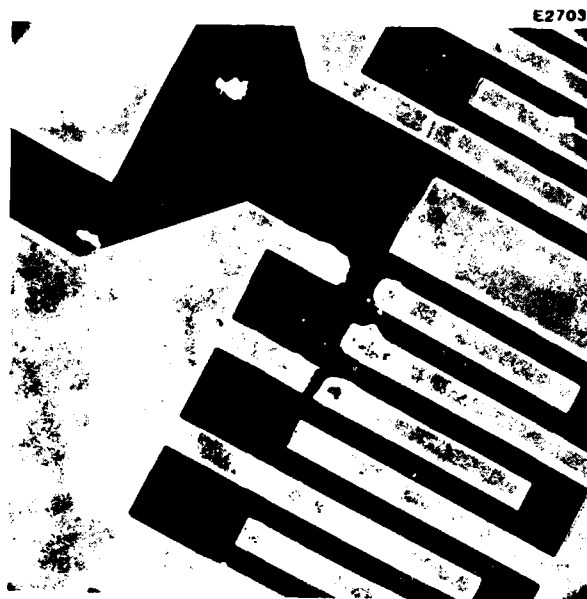
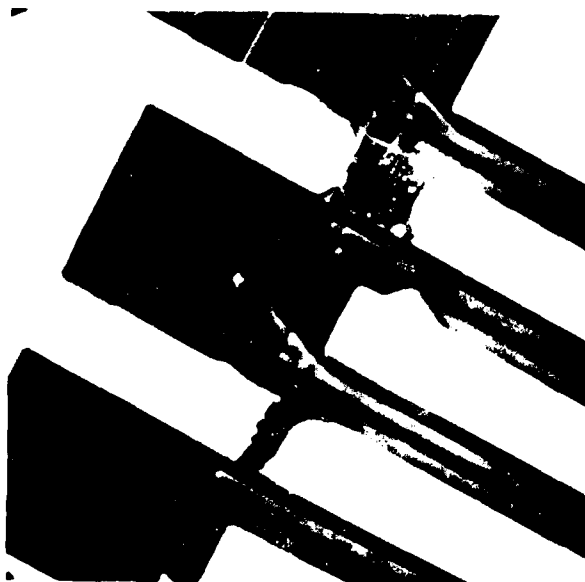
In the cases of the Type M, D and T FETs, Figure 4-10, the predominant failures were all of the "flashover" type, with smaller failures elsewhere. Primary site was at the gate pad/gate finger junction, again. In the Type N FET, Figure 4-11, the failure caused two source fingers to be melted, with those fingers not apparently shorted to the gate or drain.

Figure 4-11 Type N-250/11-P, #9, Test E.
(a) 400X. (b) 1000X. Note
melted source fingers, with
some melting of the drain
finger.

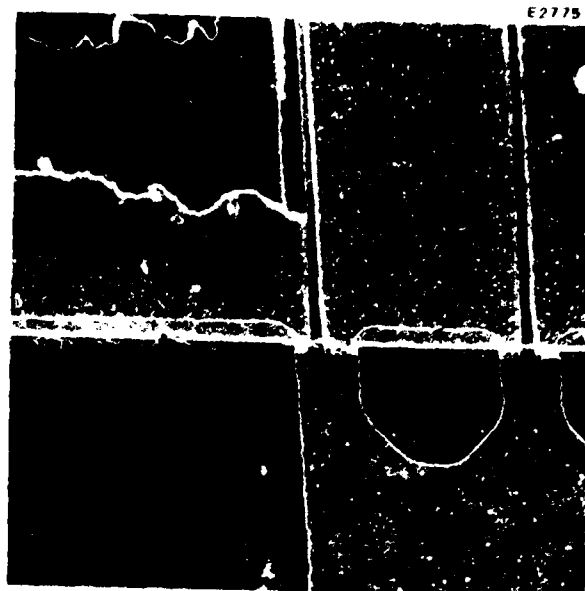
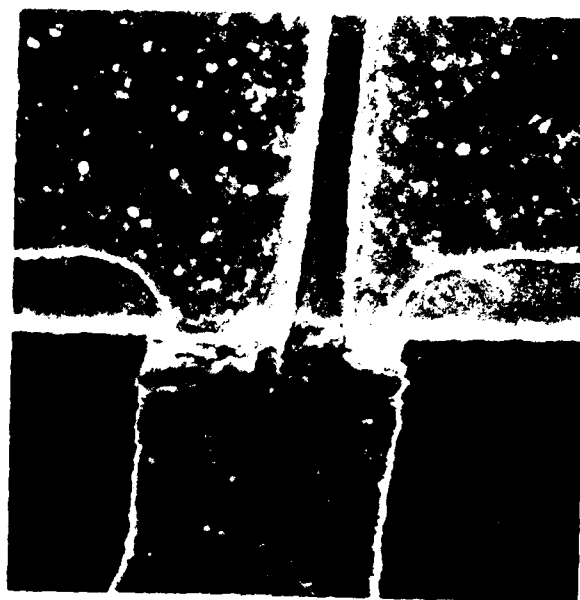
Figure 4-12 SEM photographs of the Type M-400/6 12J device. (a) 1500X; (b) 6000X.

It may be that TI received devices from a lot that for their purposes was inadequately screened by the manufacturer. We recommend that the purchaser ask the manufacturer for lot certification of the gate metallization process and that samples of incoming FETs of the Type M-400/6 be subjected to demounting and gate inspection both as received and after a burn-in period under bias.

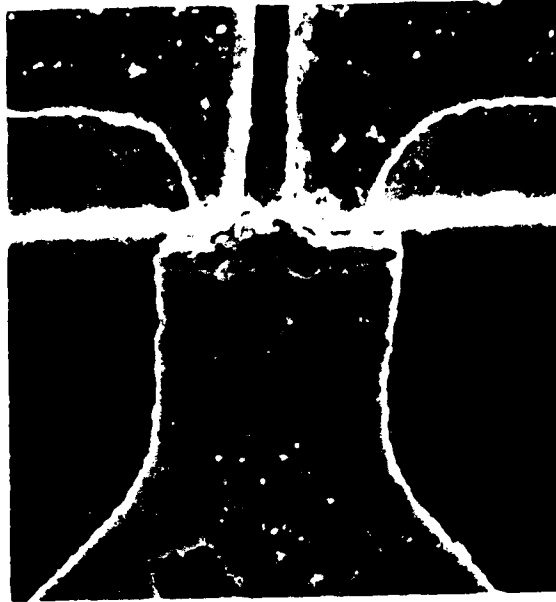
Figure 4-13 SEM photographs of the Type M-400/6 device. (a) 6000X; (b) 9600X.

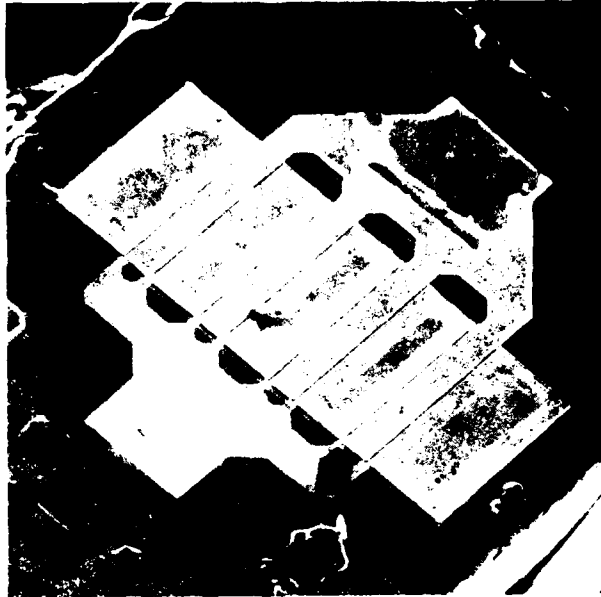
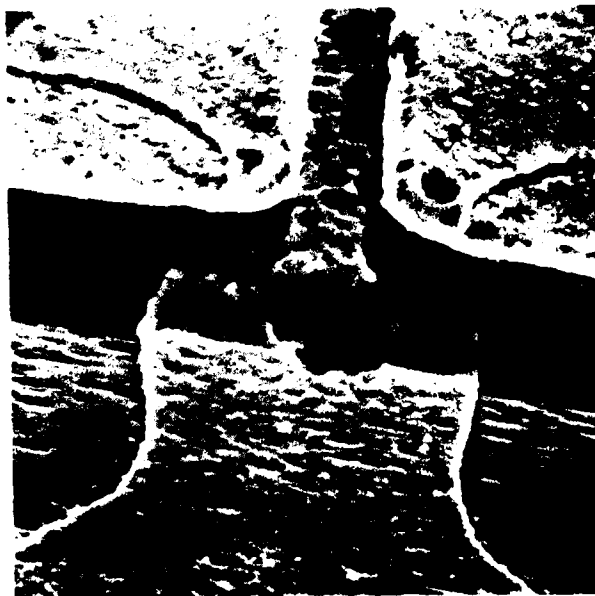
Figure 4-14 SEM photographs of the Type M-400/6 14J device. (a) 192X; (b) 6000X.

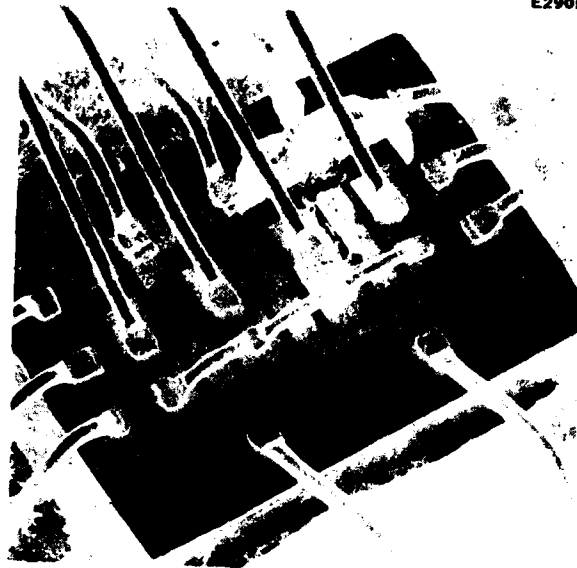
Figure 4-17(a) shows a SEM photograph of the #26 FET. Note the beautifully cleaved sides of the gallium arsenide substrate, probably the result of a well done scribe and break operation. The wire bonds have a good appearance, and the four drain pads are stitch bonded together. Again, the failure was catastrophic, involving in this device a massive melting of the source, drain, and gate electrodes.

Figure 4-17(b) shows details of the heat flow pattern and the result of resolidification. The failure of this device shows much greater heating than is apparent for device #16 (Figure 4-16). The greater heating possibly was a result of higher short-circuit current that occurred because the failure site was between a drain bond wire and source grounding leads.

Figure 4-17 SEM photographs of the Type D-250/6 #26 FET.
(a) Overall view at 120X; (b) Detail of catastrophic failure showing involvement of source, drain, and gate (270X).

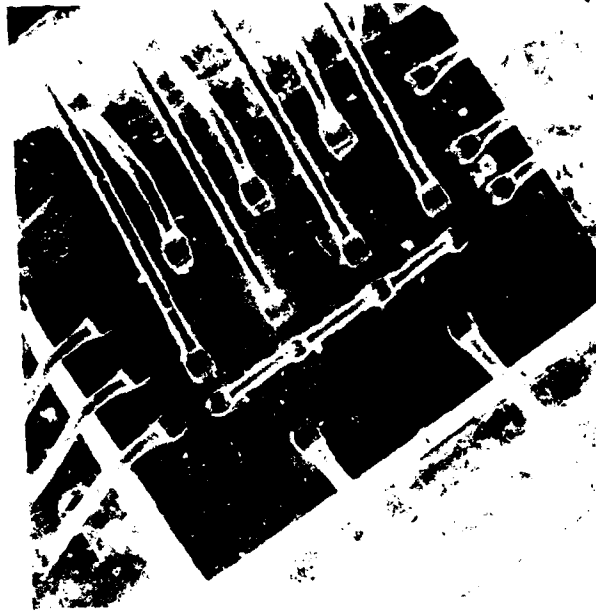
Figure 4-21 SEM photographs of the Type D-250/6 #45 device. (a) 120X; (b) 1200X.

Figure 4-21 shows the #45 FET. Although the device was reported to have a gate-to-source short, no visible evidence of gate failure was found. If the failure was small in extent and located under a stitch bonding wire, it would not be visible in the SEM, however.

Lifting of the side edge of the passivation layer at the side of a central drain pad was observed where the arrow indicates in Figure 4-21(a). Figure 4-21(b) gives a close-up view that indicates a fracture line of the passivation layer at the edge of the gold overlay on the drain pad. However, a slight delamination of the passivation layer would not directly be expected to cause device degradation and failure.

The black spots discussed earlier are again seen in the edge area of the ohmic contact gold. Voids in the gold contact are also in fact present at the edges of the ohmic contact gold under the passivation stripe. However, they are not visible in Figure 4-21(b) because only 5 kV beam voltage on the SEM was used for this picture. A more powerful 20 kV beam makes the voids visible under the glass. Less than optimum ohmic contact metallization may be implicated in the degradation of these devices, but the evidence is not conclusive.

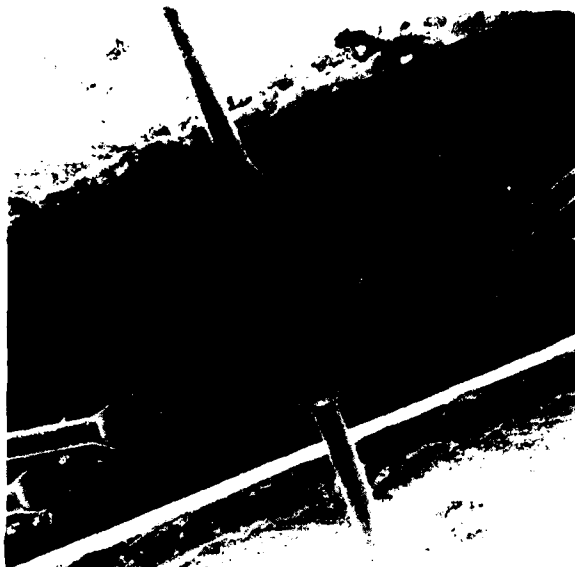
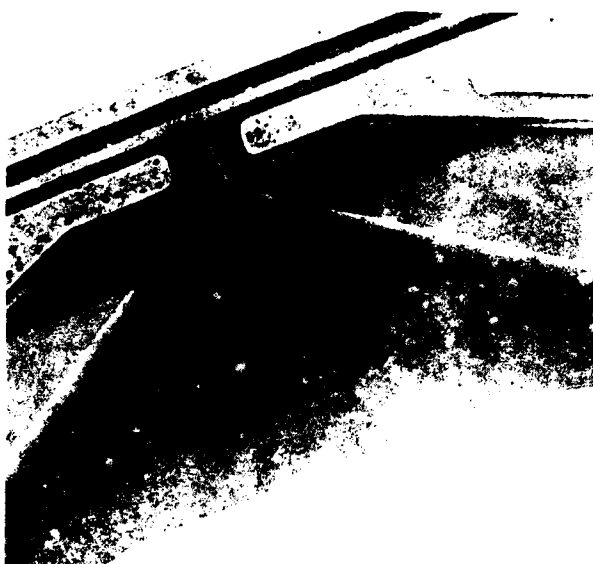
Figure A-3 Type H-1A1 #23-A FET that showed a decrease in drain current.
(a) 150X. (b) 1500X.

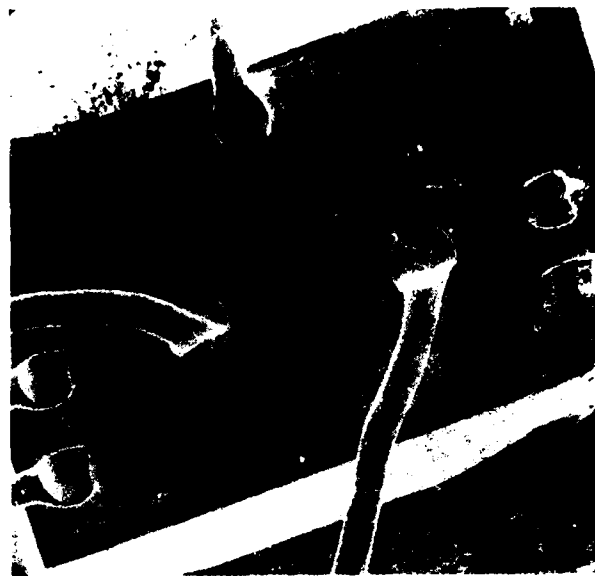
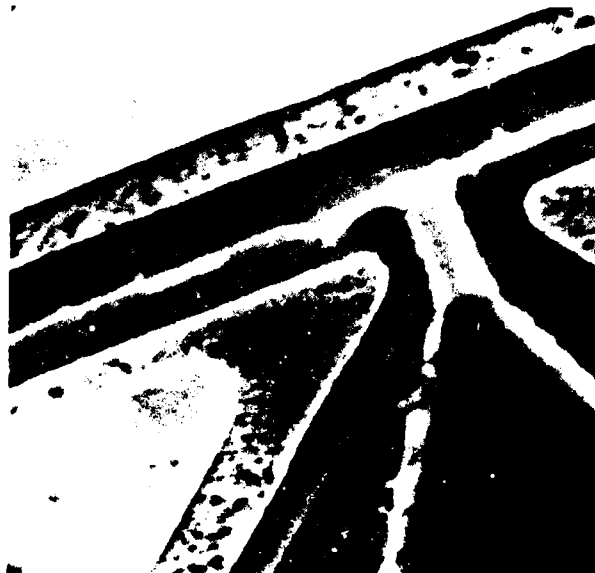
Figure A-4 Type B-21 #10 FET that lost gate control (a) 30X. (b) 4480X.

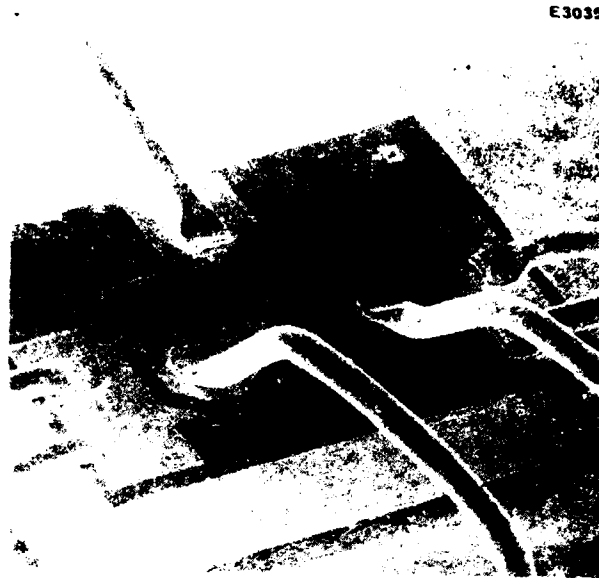
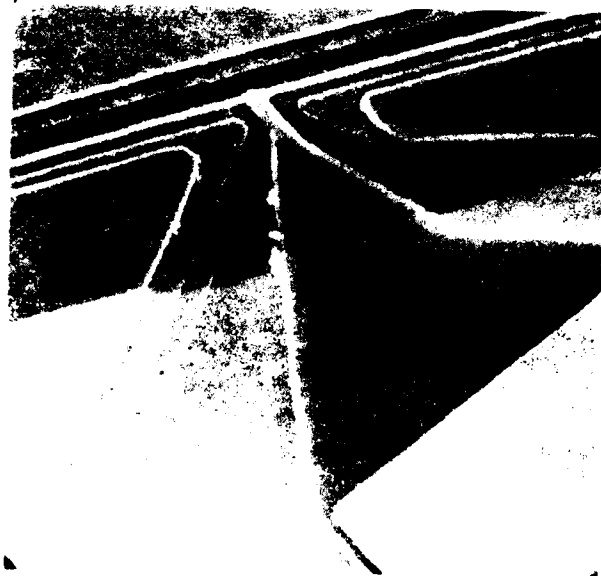
Figure A-5 Type H-21 #7 FET that showed a decrease in saturated drain current. (a) 160X. (b) 1600X.

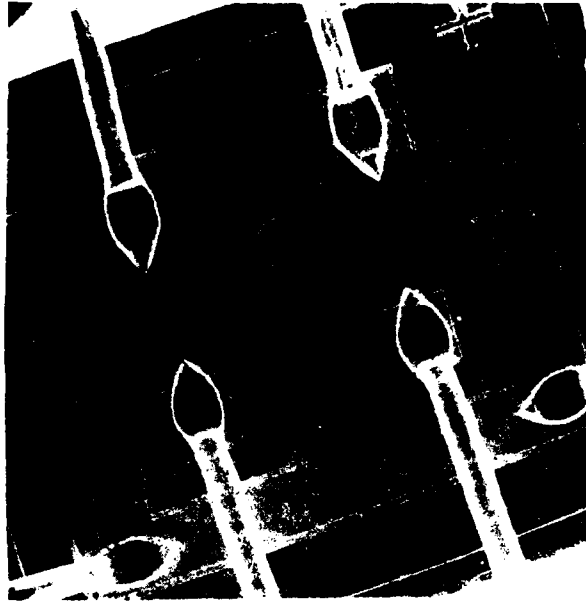
Figure A-8 Type N-1 8.5-B FET that did not fail. (a) 100X. (b) Close-up view of right gate pad connector, 1040X.

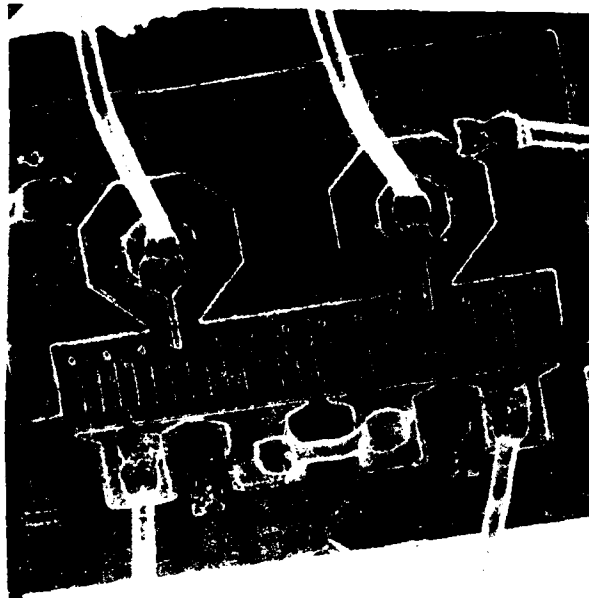
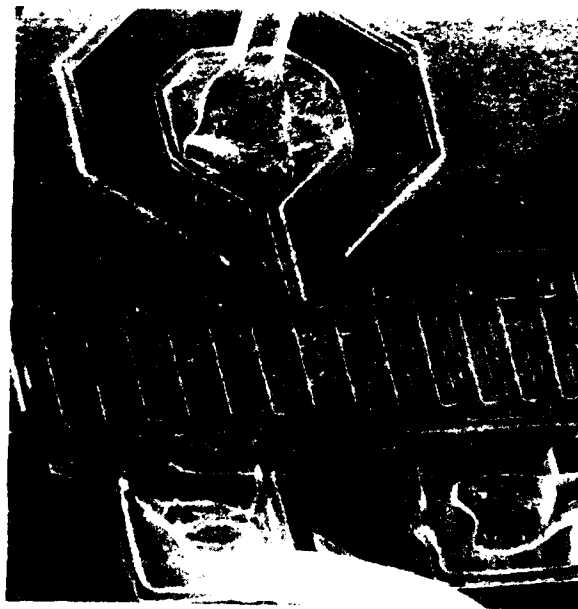
Figure A-11 Type A-51 FETs that showed a decrease in drain current.
(a) #1-B at 200X. (b) Left region of #4-D at 600X.

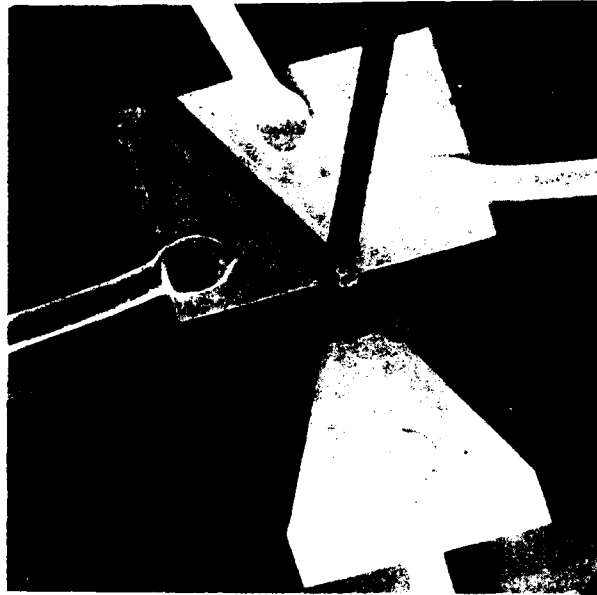
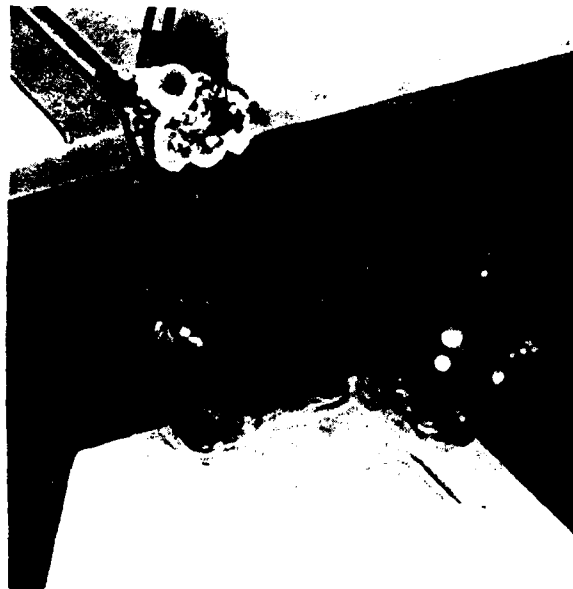
Figure A-15 Type N-21 #23 FET with a
gate-to-source short circuit.
(a) 230X. (b) 1800X.

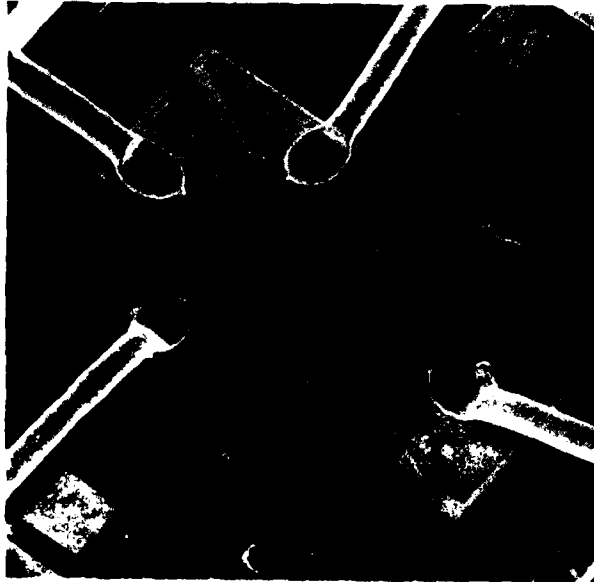
Figure A-16 Type N-21 #39 FET that showed a decrease in drain current.
(a) 200X. (b) 6000X.

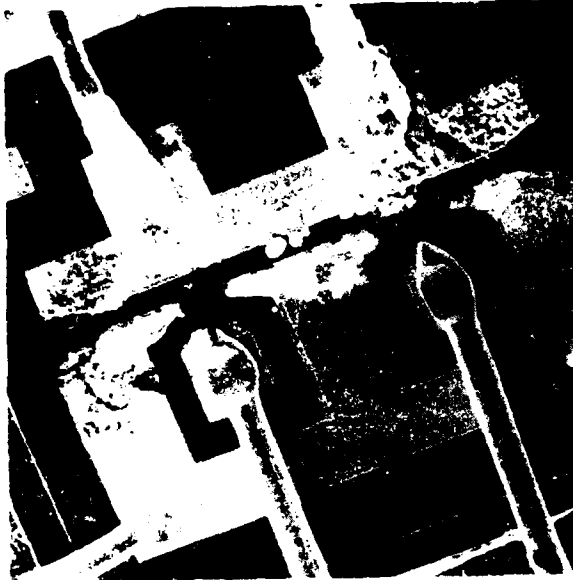
Extensive corrosion was found on the Type N-32 FET, as is evident in Figure A-17. The actual failure was a gate-to-source short circuit. However, it is apparent that the device was prone to failure because of the extensive metallization degradation. The FET failed in 96 hours at 120°C, by a factor of three the shortest time to failure of all 54 devices subjected to the medium temperature stress tests. Failures of this type could be screened out by subjecting all incoming FETs to an initial burn-in period.

Figure A-17 Type N-32 #38-B FET that failed
with a gate-to-source short circuit.
(a) 200X. (b) 520X.

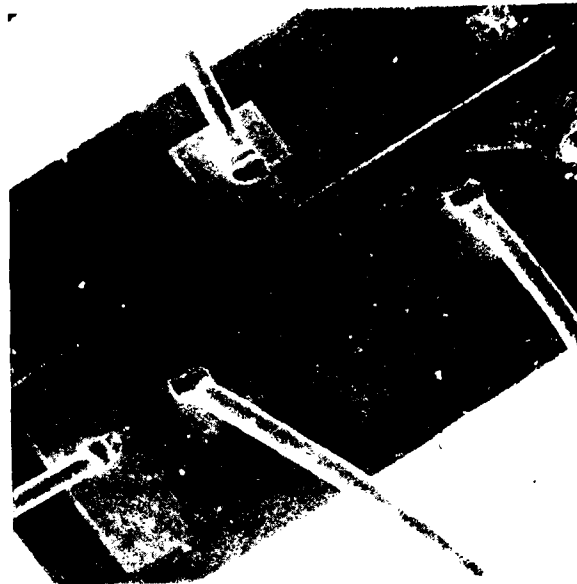
A.1.2.3 Type D-11 FET - The next FET to be placed on the RF stress test was a type D-11 device, serial number 2R. Test conditions were similar to those for the Type E-1 FET. The device logged 1087 hours of operation at 200°C baseplate temperature with -10 dBm RF input power and about 6.5 dB gain at 5.7 GHz. The RF gain was monitored regularly and changed by not more than 0.4 dB over the course of the test. This FET did not fail during the RF constant stress test. Subsequent measurements showed a leaky gate diode characteristic and excessive pinch-off voltage.

We terminated the test and delidded the package to examine the FET chip. Figure A-21(a) shows an overall SEM photograph of the failed device. Figure A-21(b) shows a magnified view of the left gate connector. Slight mottling of the source and drain ohmic contact metallizations is evident. The gate transition is imperfectly formed. However, it was not apparent that this construction defect affected either the DC measurements or RF performance. The gate metal is gold, and the gate width is nominally one micrometer.

Figure A-21 (a) SEM photograph of the Type D-11 #2R FET at 200X; (b) Close-up of the left gate connector region at 3000X.

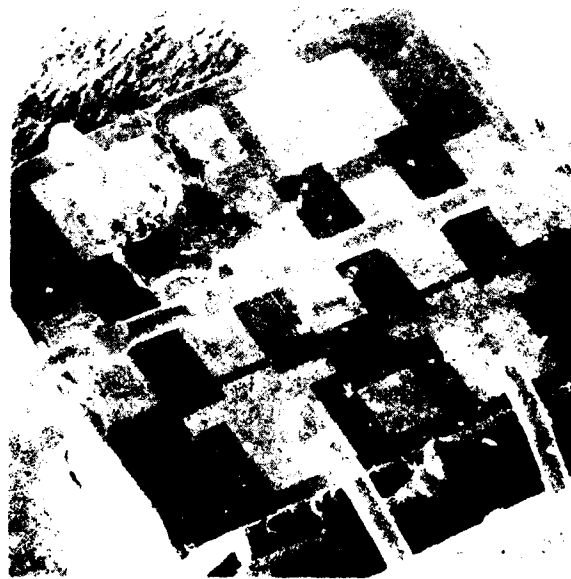
Figure A-24 Test A failures. (a) Type T-LAB No. 17 FET at 250X.
(b) Type T-X500/8 No. 13J FET at 250X.
